Settle - Bridgend Mill

Fisheries Assessment

Client: Water Power Enterprises

Project: River Ribble- Settle. August 08

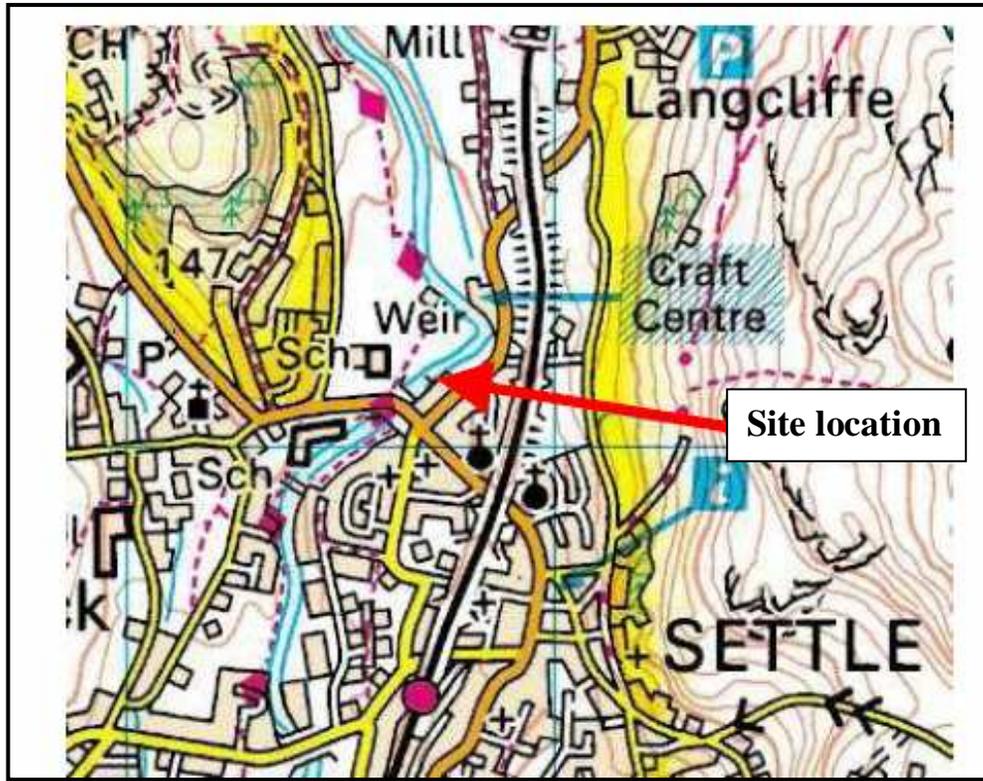
Figure 2. Map of Site

The Ribble is a fast flowing upland eroding river, rising within the Yorkshire Dales National Park and flowing South West to join the Irish Sea at Southport. Total catchment above Settle is 124 km² with average rainfall of 1582mm. It has a number of old mills along its length, most of them now defunct. Bridgend Mill is situated on the Northern edge of Settle.

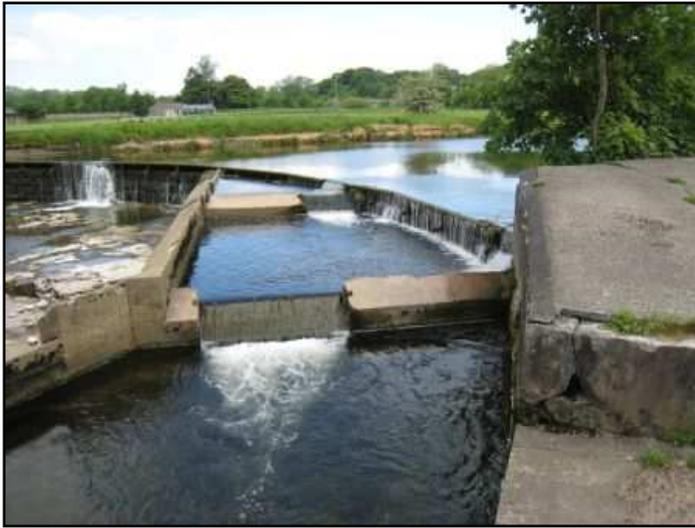
Figure 4. Pass at 0.336 m³/s, just below Q90

Figures 4-7 below show the pass at different river levels. Figure 4 = 0.336 m³/s., with the pass drawing well below the proposed HOF of 400l/s. Figure 5 = 1.15m³/s (Q65). Approx. 400-500l/s is flowing in the pass and energy densities are well within the maximum 200 watts/m³ (EA Fish Pass manual). Figure 6=1.78 m³/s (Q50). A significant volume of water is in the pass with energy densities above 200 watts/m³. Figure 7 =14.5 m³/s, just above Q10 with energy levels above 500 watts/m³.

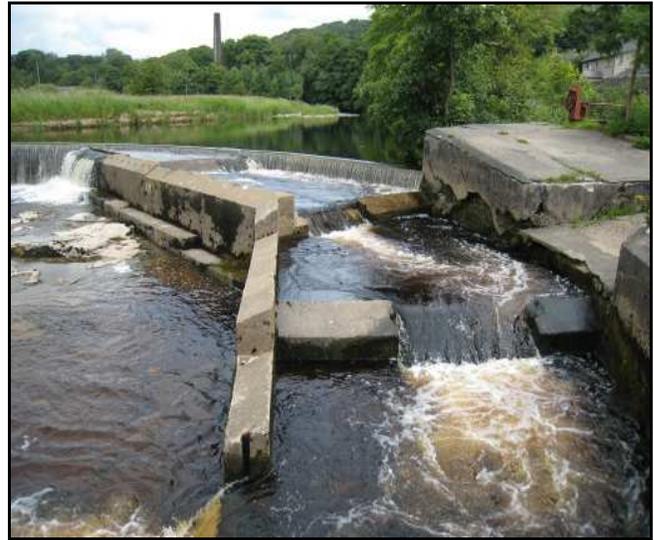
Figure 5. Pass at 1.15m³/s (Q65)

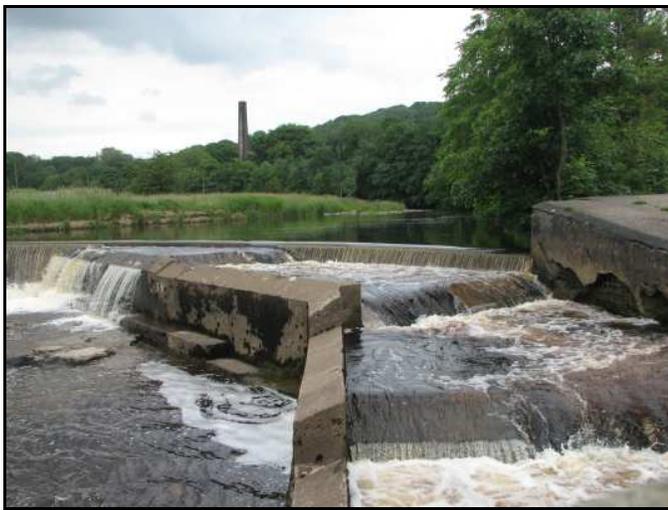
Figure 6. Pass at 1.78m³/s. (Q50)

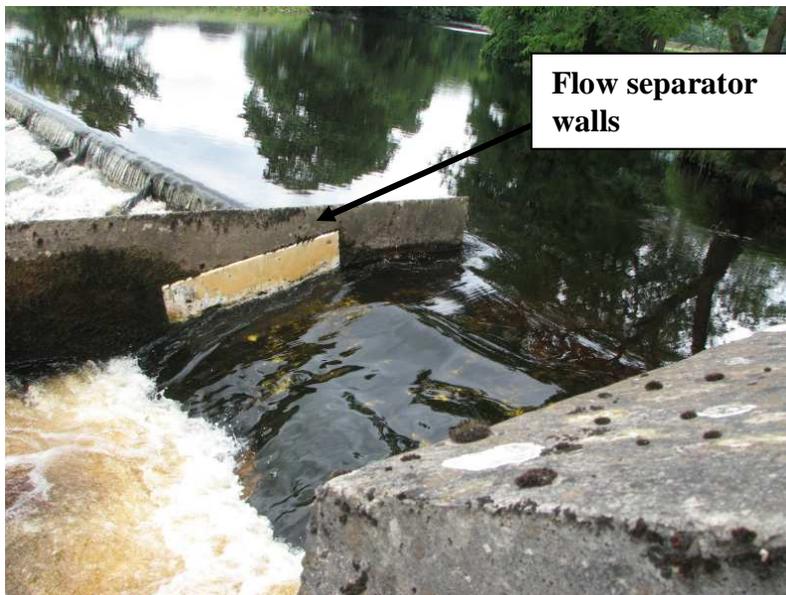
Figure 10. Fish pass at Locks weir

window.Improvements to the top of the pass, such as installing separator walls as shown in figure 10 to reduce the intake at high flows and removing boulders that currently reduce pool depth would further improve efficiency across the flow range. Currently, energy levels in the pass exceed 200watts at about Q40. The proposed abstraction could extend this to Q10, reducing delay for upstream migrants.

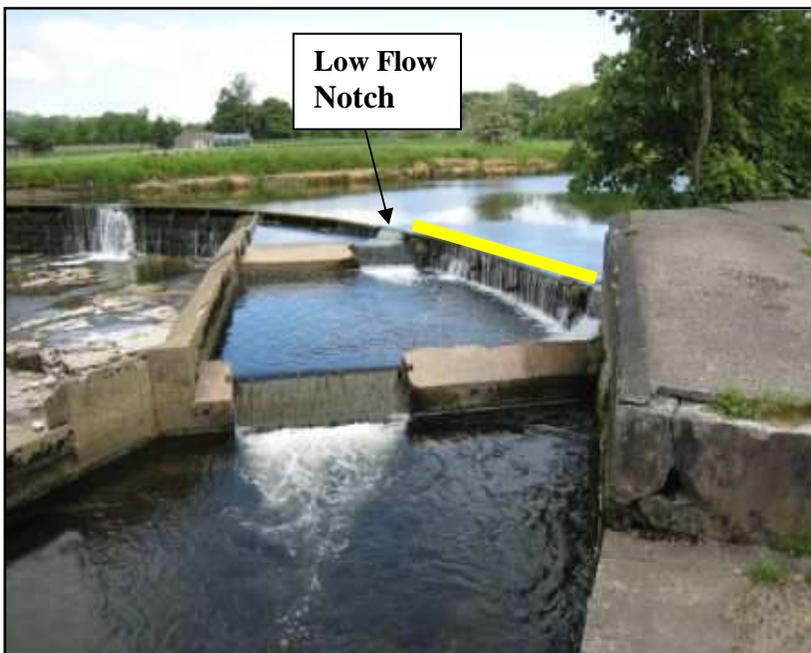
Figure10a. Modifications to reduce flow in pass and prevent fish being drawn into leat.

A short section of wall separating the intake to the sluice from the fish pass exit would be needed to prevent recently ascended fish being re-cycled through the screw. If the section of weir shown in yellow in figure 10a below was built up, it would reduce flow into the pass at high river levels and put the fish pass exit far enough away from the intake to prevent fish being re-cycled. This section already has a low flow notch; (see fig. 10a) however, this may need to be extended to ensure the pass draws most of the water at HOF.

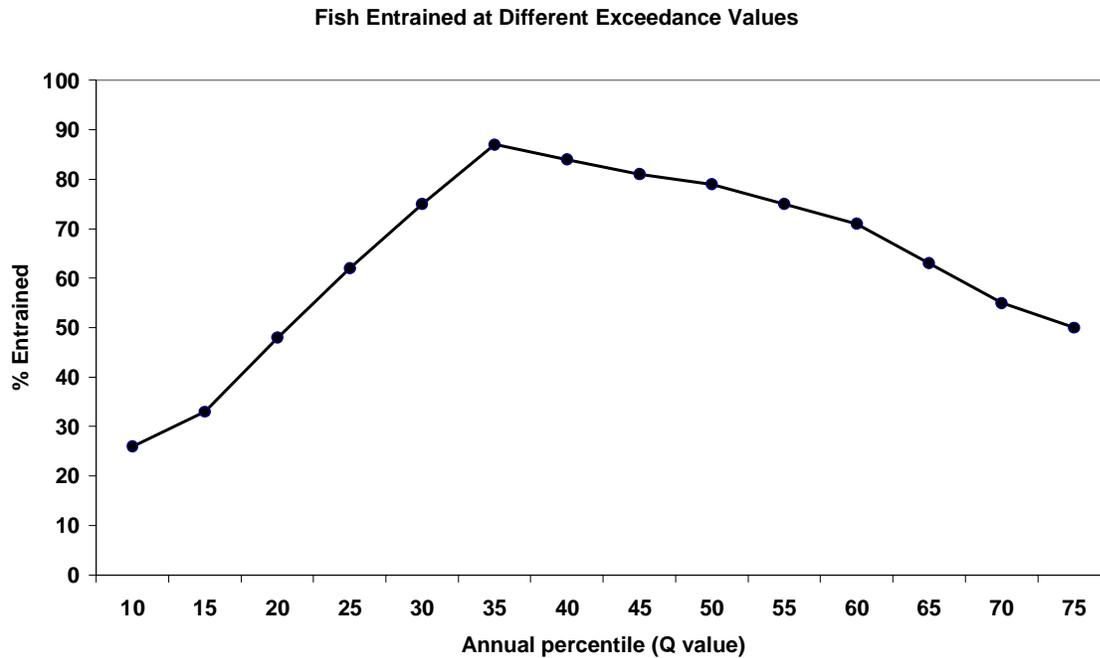
Figure 11. Proportion of downstream migrants entrained in turbine intake

water conditions, below Q75; therefore the proportion of fish entrained at river levels above this was calculated. Results are shown in figure 11. The actual proportion would depend on the flows during the migration period, April-May for smolts and November-January for kelts. It seems likely that a significant number of fish, especially smolts would pass through the turbine if it runs unscreened. Extensive trials on the River Dart in Devon (section 6.1) have shown that adult and juvenile salmonids can pass the screw unharmed; therefore this is unlikely to be an issue. If fish actively avoid the intake, the fish pass would form an effective bywash. A second bywash alongside the screw is probably not needed as the intake leat is very short (<15m) and large fish avoiding the screw could easily swim back into the main river and down the fish pass.

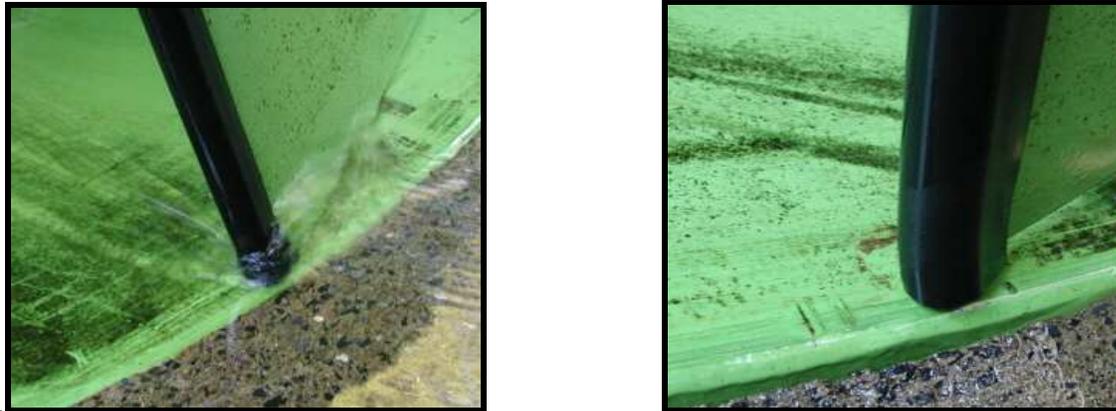
Figure 12. Modified leading edge with rubber extrusions

To resolve this issue, the turbine monitored on the river Dart by Fishtek Consulting has been installed with rubber extrusions along each leading edge, see figure 12. These serve two functions; firstly they prevent the edge from being damaged by stones and secondly any contact with larger fish is softened and extremely unlikely to cause damage. The tip speed of the end of the helix is under 4ms⁻¹ generally regarded as the threshold impact speed below which there is no damage to fish. (Turnpenney et al, 2000).

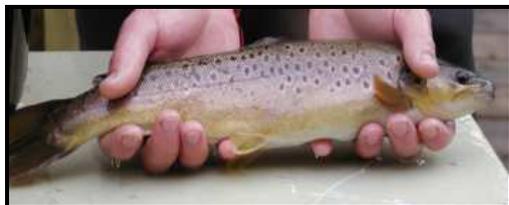
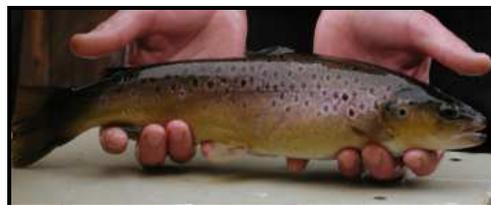
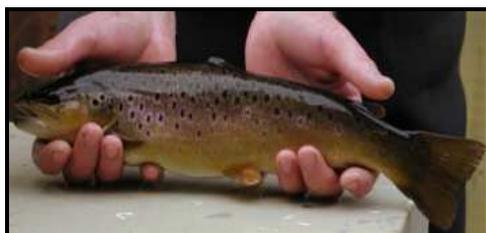
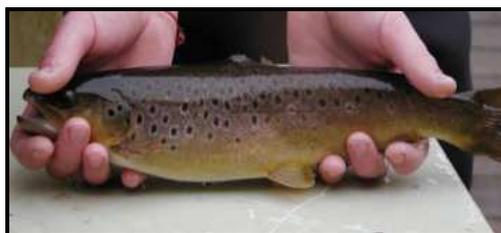
before

after

Figure 13. Brown trout photographed before and after passing through the turbine.

Examples of fish photographed before and after passing through are shown in figure 13 below.
